Does Increased Rainstorm Intensity Pose Risks to County
Infrastructure? A study from Nicollet and Sibley Counties in
Minnesota

A thesis submitted in partial fulfillment of the requirements of the degree of
Bachelor of Arts
(Geology)
at
Gustavus Adolphus College
2018

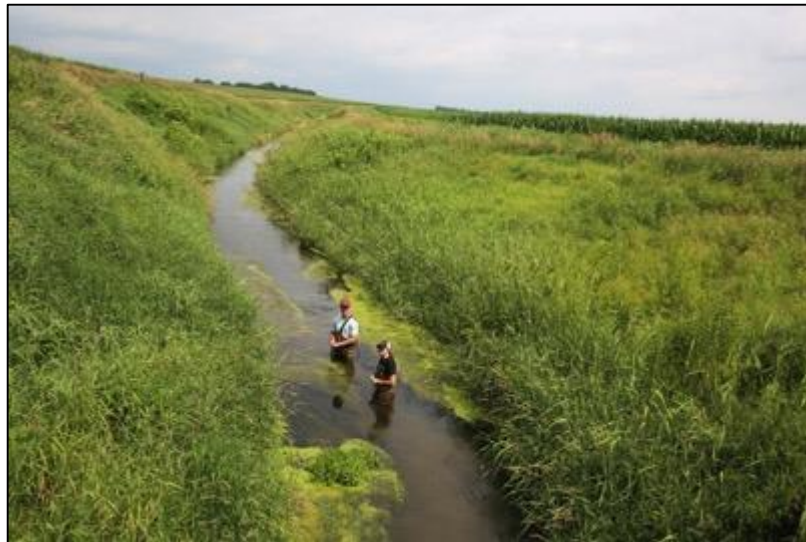
Figure 1. This is an example of an open drainage ditch in south-central Minnesota.

Open drainage ditches (*Figure 1*) can be found all over southern Minnesota and are an important structure for growing crops like corn and soybeans in regions where natural soils drain slowly. These structures swiftly drain water from agricultural fields to avoid flooding and standing water, which can lead to ruined crops (Needelman et al. 2007). Ditches receive water that flows out of drainage tiles beneath the fields, and transport it to natural streams and rivers. Open drainage ditches usually have a “V”-shaped cross-section and have vegetation growing on both sides (*Figure 1*). In southern Minnesota, known for its sprawling agricultural fields, it is not uncommon to see this type of drainage ditch between fields and occasionally crossing beneath roads when necessary.

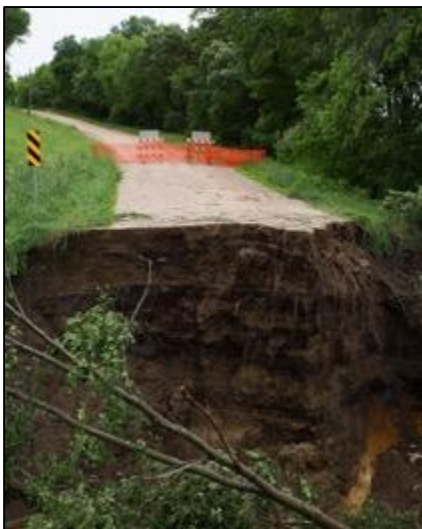
Figure 2. (Above) Road washout in Belle Plaine, MN in 2014. (Ruud, 2014)

during rain events these ditches can fill quickly in some areas, leading to possible flooding hazards surrounding infrastructure such as roads. One example of infrastructure being damaged occurred in June 2014 in Belle Plaine, MN. Sibley County Road 6 (Scenic Byway) was washed out (**Figure 2**) after approximately 7.6 inches of rain fell in a single storm (Ruud, 2014). Another instance where infrastructure was severely damaged by flooding occurred in Courtland, MN in June 2016 when 506th Street was completely washed out (**Figure 3**) (Buletti, 2016).

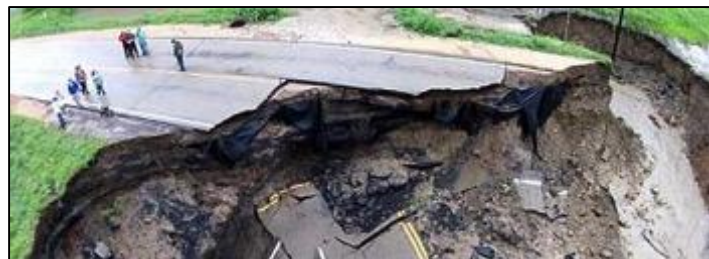
Figure 3. (Left) Road washout in Courtland, MN in 2016. (Buletti, 2016)

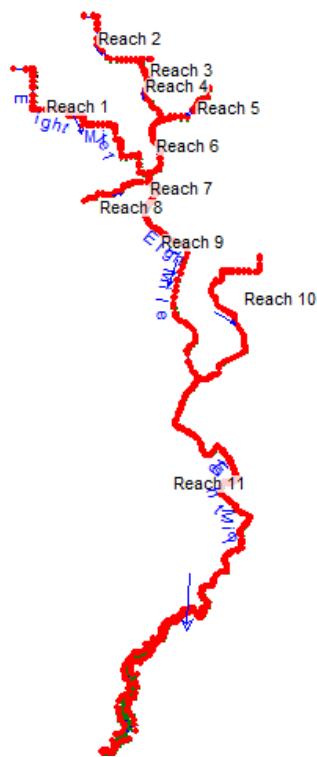
Figure 5. The layout of the Eight Mile Creek ditch system in HEC-RAS. Each section of the system is labeled as a reach.

Three flow profiles were calculated for the Eight Mile Creek watershed. These profiles included flow measurements for each reach of the Eight Mile ditch system (**Figure 5**) at average flow, 2-year flood discharge, and 20-year flood discharge. The values for these flows were determined based on the Department of Natural Resources (DNR) hydrograph based on flow measurements in nearby Seven Mile Creek, which is a similar watershed on the east side of the

The HEC-RAS model output depicted three culverts being affected by the flow discharge scenarios. These were culverts number 14, 29, and 33, none of which are beneath county roads. Culvert 14 is located in Reach 10, Culvert 29 is located in Reach 1 and Culvert 33 is located in Reach 8 (**Figure 5**). Culvert 14 and Culvert 33 were interestingly flooded for all three scenarios (**Figure 8** and **Figure 9**). The reason behind this could be a geometry issue within the HEC-RAS model possibly due to the LiDAR picking up vegetation as the bottom of the ditch. In this way, the ditch channel would appear shallower and thus easier to flood. The other possible reason behind this could be that these particular culverts may be in serious need of replacement. Given that Culvert 33 is placed beneath a driveway to a farm it is more likely that there is a geometry issue in the model rather than the driveway to someone's farm being continually flooded.
