Does Increased Rainstorm Intensity Pose Risks to County
Infrastructure? A study from Nicollet and Sibley Counties in
Minnesota

By
Caitlin Clause

Bachelor of Arts
(Geology)

Gustavus Adolphus College

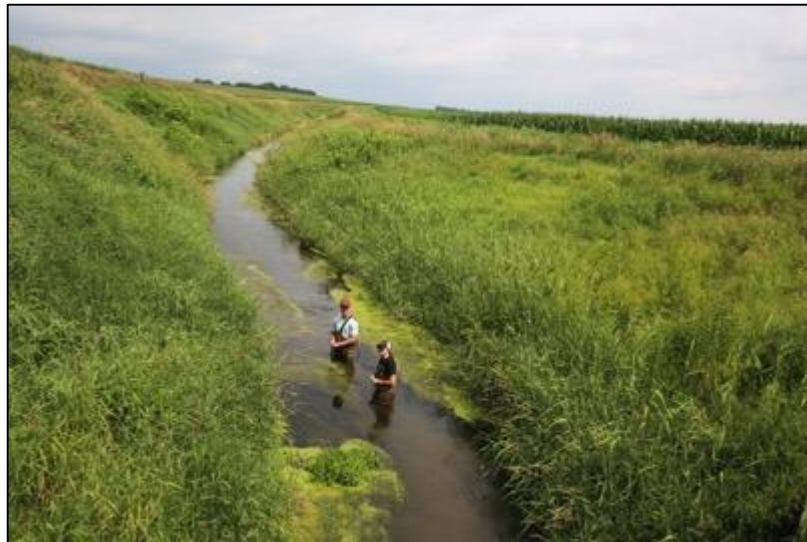
Figure 1. This is an example of an open drainage ditch in south-central Minnesota.

Open drainage ditches (*Figure 1*) can be found all over southern Minnesota and are an important structure for growing crops like corn and soybeans in regions where natural soils drain slowly. These structures swiftly drain water from agricultural fields to avoid flooding and standing water, which can lead to ruined crops (Needelman et al. 2007). Ditches receive water that flows out of drainage tiles beneath the fields, and transport it to natural streams and rivers. Open drainage ditches usually have a “V”-shaped cross-section and have vegetation growing on both sides (*Figure 1*). In southern Minnesota, known for its sprawling agricultural fields, it is not uncommon to see this type of drainage ditch between fields and occasionally crossing beneath roads when necessary.

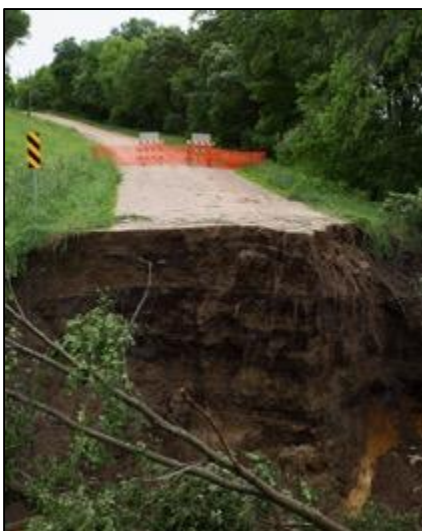
Figure 3. (Above) Road washout in Belle Plaine, MN in 2014. (Ruud, 2014)

during rain events these ditches can fill quickly in some areas, leading to possible flooding hazards surrounding infrastructure such as roads. One example of infrastructure being damaged occurred in June 2014 in Belle Plaine, MN. Sibley County Road 6 (Scenic Byway) was washed out (*Error! Reference source not found.*) after approximately 7.6 inches of rain fell in a single storm (Ruud, 2014). Another instance where infrastructure was severely damaged by flooding occurred in Courtland, MN in June 2016 when 506th Street was completely washed out (*Error! Reference source not found.*) (Buletti, 2016).

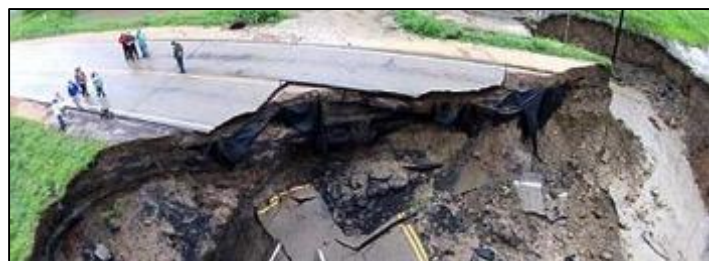
Figure 3. (Left) Road washout in Courtland, MN in 2016. (Buletti, 2016)

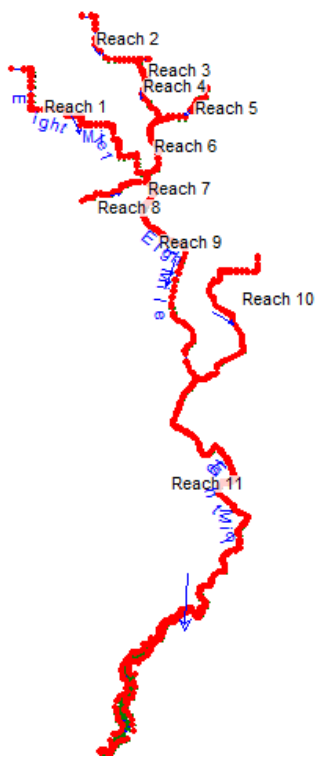
Figure 5. The layout of the Eight Mile Creek ditch system in HEC-RAS. Each section of the system is labeled as a reach.

Three flow profiles were calculated for the Eight Mile Creek watershed. These profiles included flow measurements for each reach of the Eight Mile ditch system (**Figure 5**) at average flow, 2-year flood discharge, and 20-year flood discharge. The values for these flows were determined based on the Department of Natural Resources (DNR) hydrograph based on flow measurements in nearby Seven Mile Creek, which is a similar watershed on the east side of the

The HEC-RAS model output depicted three culverts being affected by the flow discharge scenarios. These were culverts number 14, 29, and 33, none of which are beneath county roads. Culvert 14 is located in Reach 10, Culvert 29 is located in Reach 1 and Culvert 33 is located in Reach 8 (*Figure 5*). Culvert 14 and Culvert 33 were interestingly flooded for all three scenarios (*Figure 8* and *Figure 9*). The reason behind this could be a geometry issue within the HEC-RAS model possibly due to the LiDAR picking up vegetation as the bottom of the ditch. In this way, the ditch channel would appear shallower and thus easier to flood. The other possible reason behind this could be that these particular culverts may be in serious need of replacement. Given that Culvert 33 is placed beneath a driveway to a farm it is more likely that there is a geometry issue in the model rather than the driveway to someone's farm being continually flooded.

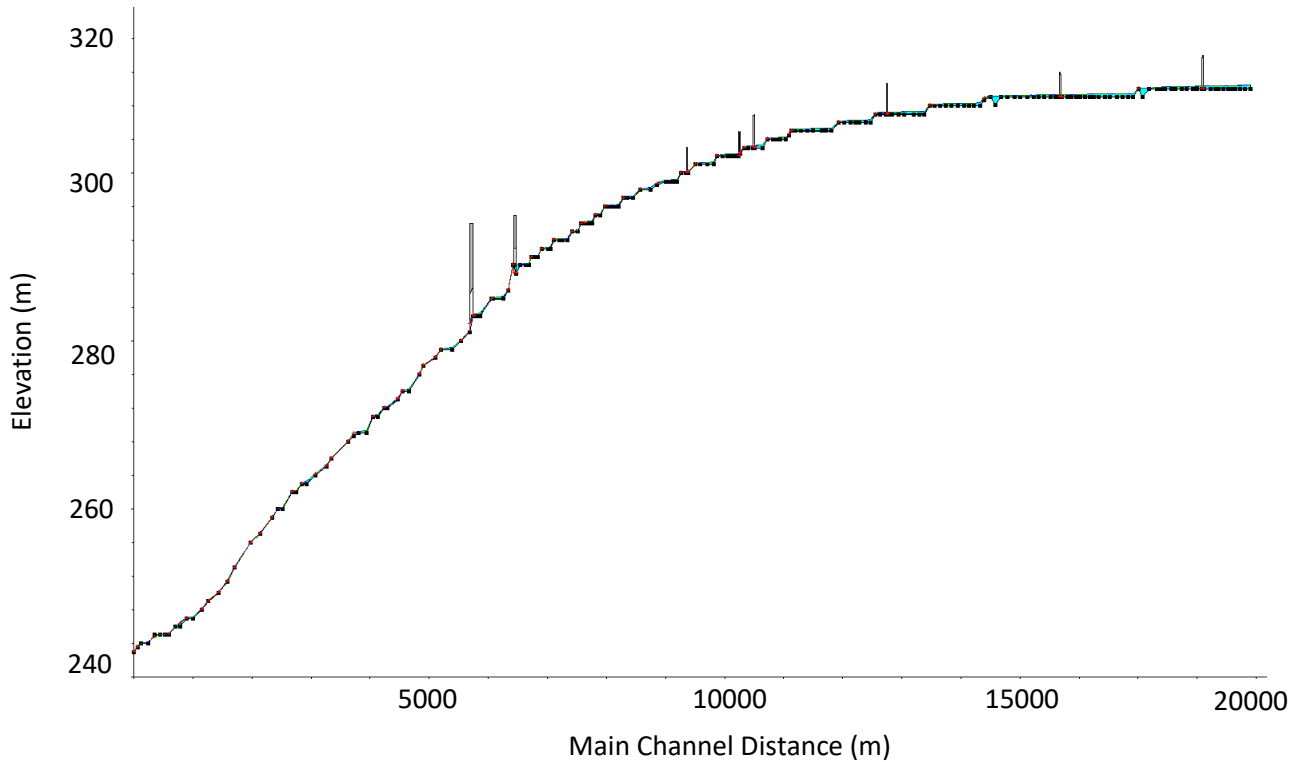
Figure 6. The elevation profile of Reach 11 with the left side of the graph representing downstream. The vertical lines represent culverts located along the channel. The upstream section of the Eight Mile ditch system is very flat, whereas the downstream section of Reach 11 shows significant elevation decline.

county. Seven Mile Creek and Eight Mile Creek are similar in size (to within 1,000 acres). Also, both watersheds have most of their area on the low-slope glacial till plain, then the trunk stream drains steeply down to the Minnesota River (*Figure 6*). The ditch systems are fully channelized, and only meander once they exit the farm fields on the uplands. And, both have similar ditches in terms of size, shape, and vegetation.
