Assessing Differences in Ravine Erosion in Seven Mile Creek
Park and the Surrounding Area: Implications for Sediment in the
Minnesota River

A thesis submitted in partial fulfillment of the requirements of the degree of

(Geology)

Gustavus Adolphus College

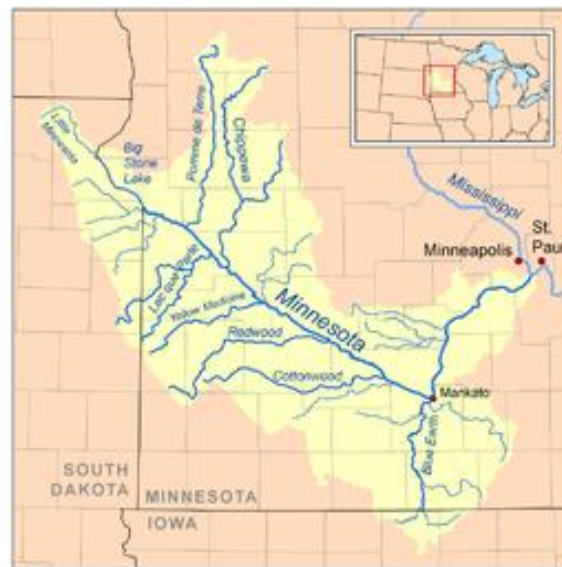
Figure 1.2: Showing the Minnesota River and its tributaries, created by Glacial River Warren.

used for this study of non-eroding ravines, is ravines with vegetation covering it. The vegetation will stay on the ravines when the ravine is not actively eroding. The overall surficial geology of south-central Minnesota is unconsolidated, fine grained material. The unconsolidated material can consist of layers of unsorted silt and clay or sand. My study area of Seven Mile Creek Park and the surrounding area is underlain by unconsolidated silt, clay, and sand. The sorted clay comes from proglacial lakes and the sand is coming from glacial rivers. The glacier deposited the unsorted sediment. Figure 1.2 shows the Minnesota River and the different tributaries that were carved out.

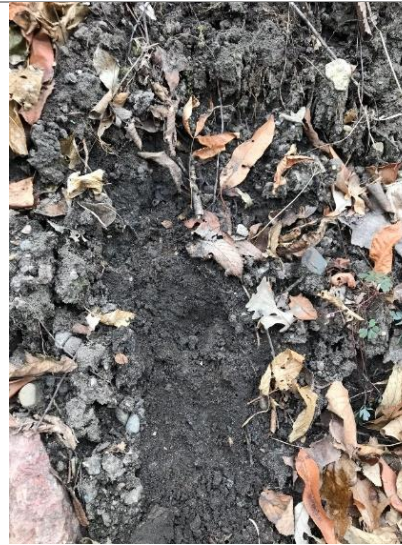
Figure 10: Till or soil material as seen in the sample from the non-eroding Ravine 3 in Seven Mile Creek Park.

The first sample from this ravine came from closest to river. All the samples consisted of till or soil material. It was well sorted throughout. On the very outside of the side of the ravine, there were bigger rocks. The ravine was pretty uniform throughout, samples were taken towards the river, the general middle, and farther up from the middle.

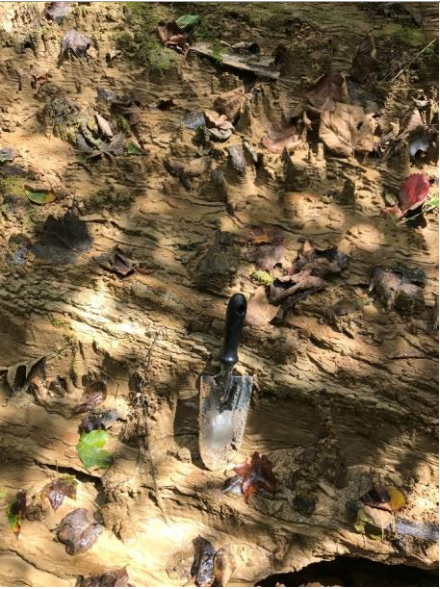
<p><u>Figure 11:</u> Clay material, like in Sample 9.</p>
5	<p>Sample 10: Fredricks' east ravine stop 3</p>	<p>Branch of ravine that goes up east side of Frederick's property. Till and colluvium about 1.5 meters from ground level. What counts as ravine wall material or is this sample too high above where the water would be flowing. This one might not count as an erosional ravine because of this.</p>

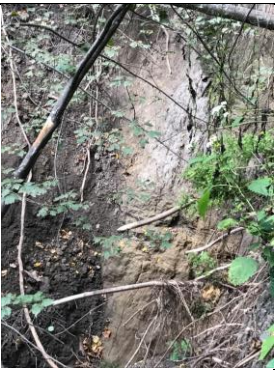
<p><u>Figure 12:</u> View from towards the top of the ravine.</p>

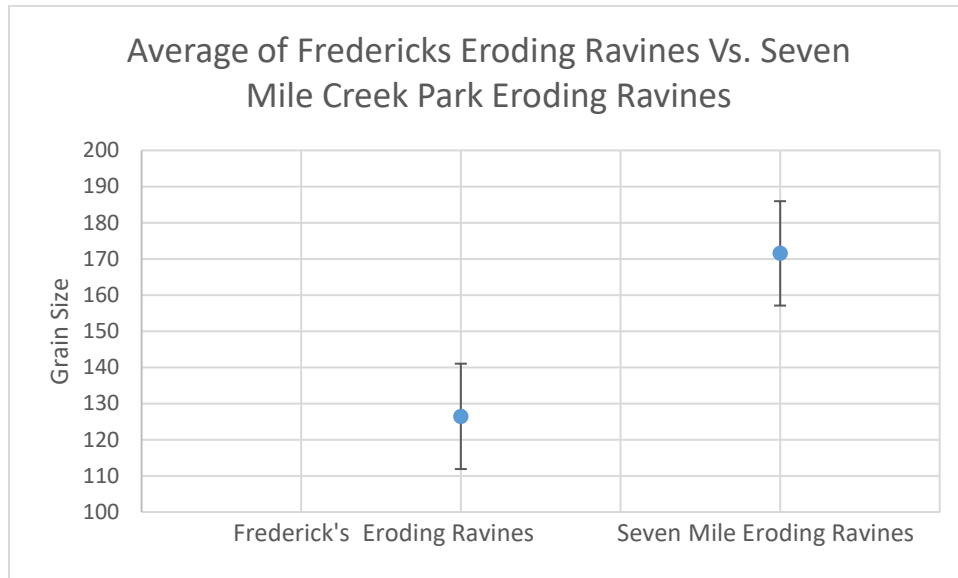
Figure 15: The average grain size of Frederick's eroding ravines (Ravines 4&5) versus Seven Mile Creek Park (Ravines 1&2) average grain size of eroding ravines.

Ravines 4 and 5 were included in the Frederick's' eroding ravines average. Eroding ravines 1 and 2 from Seven Mile Creek were combined using their previous average to get the new average for the two ravines (Figure 15). The error bars of standard deviation from the Frederick's' eroding ravines versus Seven Mile Creek Park ravines barely do not intersect one another in grain size average. All the ravines tend to be skewed towards fine grain, but often have a bimodal grain size distribution.

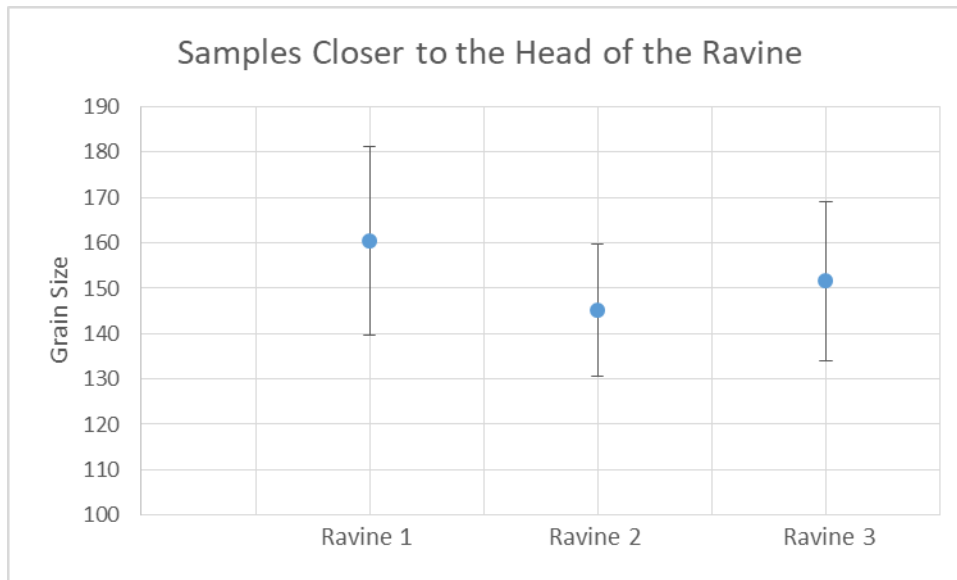
Figure 16: Sample from each ravine that were taken closer to the head of the ravine in Seven Mile Creek Park.

The three ravines in Seven Mile Creek Park show that the grain sizes are very similar when taken closer to the head of the ravines (Figure 16)..

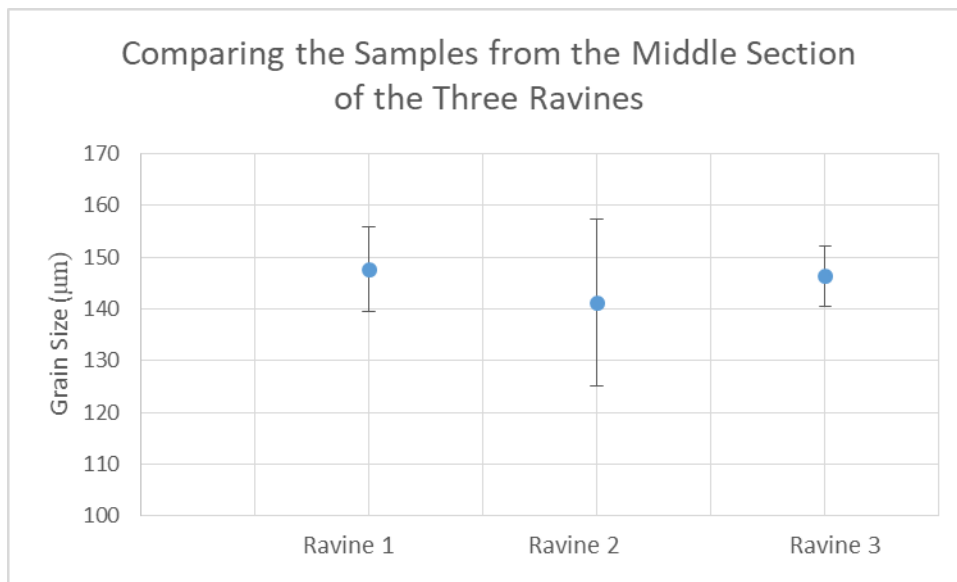
Figure 17: Samples from each ravine that were taken from closer to the middle section of each ravine in Seven Mile Creek Park.

The three ravines from Seven Mile Creek Park show that there is a very similar grain size for each of the ravines in the middle section of the ravine (Figure 17).
