THE IMPACTS OF AGRICULTURAL DITCHING ON THE HYDRAULIC GEOMETRY OF STREAMS

by
KRISTIN M. ANDERSON

A thesis submitted in partial fulfillment of the requirements for the degree of
Bachelor of Arts
(Geology)
at
GUSTAVUS ADOLPHUS COLLEGE
1998

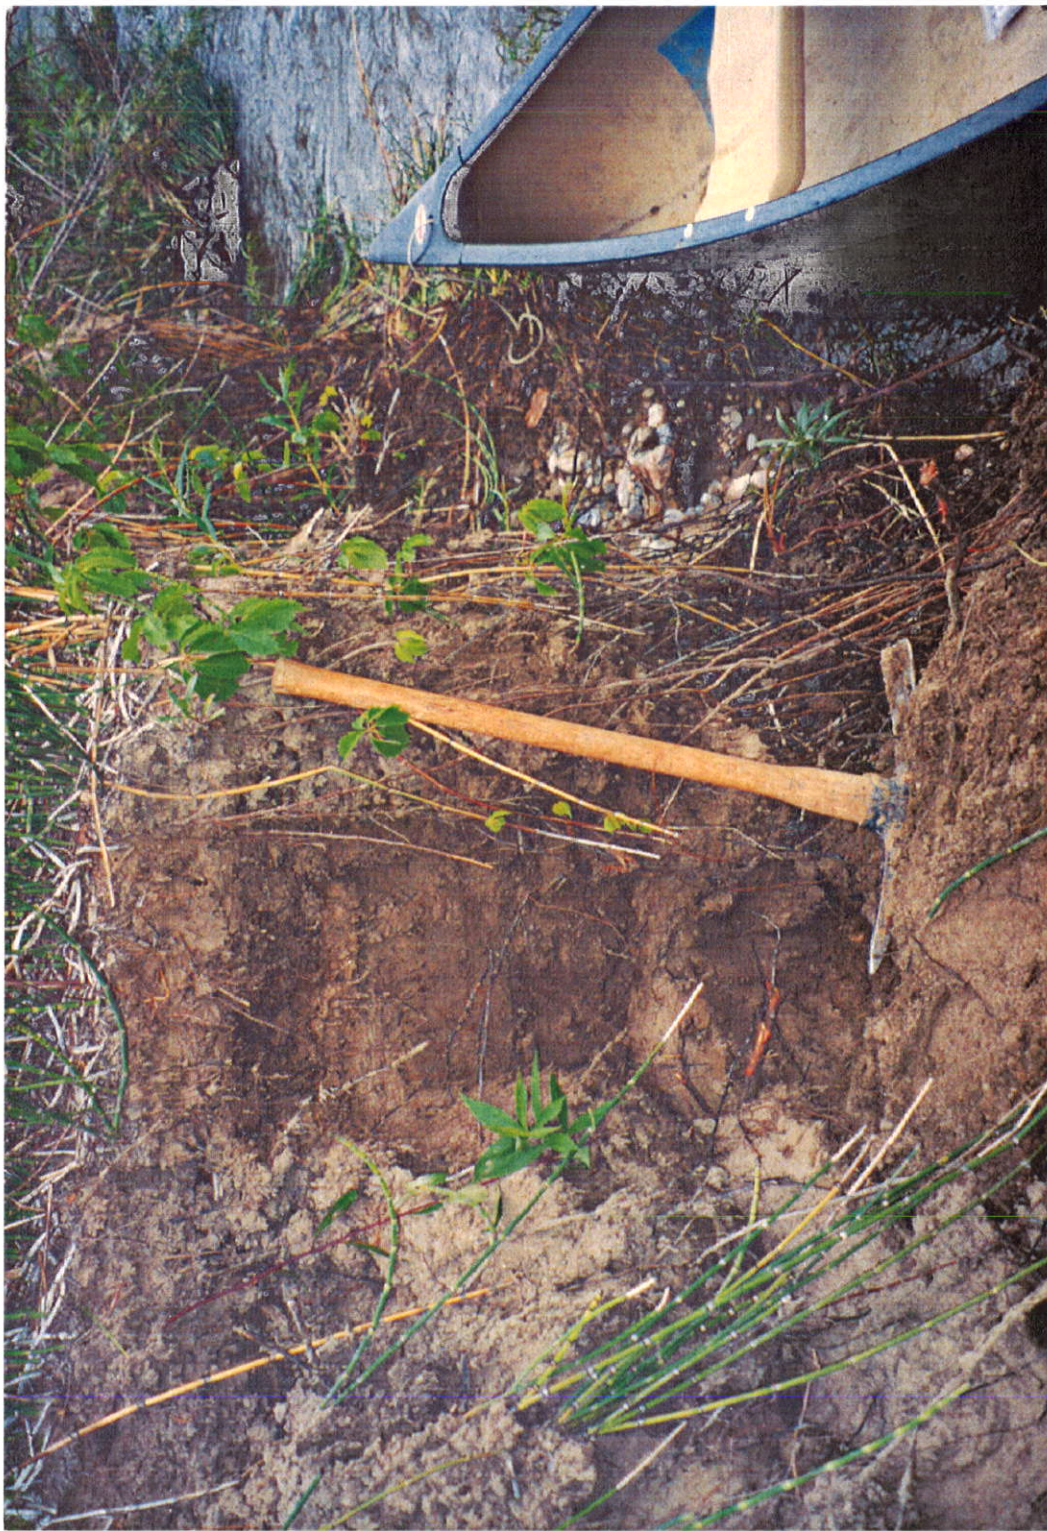
Figure 3. Sediments found in Rush River floodplain deposits. At the level of the top of the pick handle is a dark, vegetated layer of sediment. Above this is a lighter layer of fine sand and silt, interpreted to be post settlement alluvium.

Post settlement alluvium (PSA) on the floodplain of a stream is indicative of changes in stream character since the time of settlement by an agricultural society. Sediment load of a stream is a function of the stream's equilibrium (Schumm and others, 1987). A layer of alluvial floodplain sediment (PSA) over a buried topsoil layer that can be dated to the time of European settlement in our study area clearly shows a change in the stream systems since the onset of agriculture. We found lighter layers of sand and silt over a darker, organic layer of sediment in the lower reaches of both High Island Creek and the Rush River. A photo of these sediments that we found on the Rush River floodplain is shown in Figure 3. This is very similar to what Beach (1994) described as PSA in his studies. He also indicated that he found PSA dated to the time of settlement in the Rush River stream system. Though this alluvial sediment does show change in the stream system, it is very hard to separate the variables contributing to it. Land clearing and vegetation changes from farming happened in a very similar time frame as ditching did. The amount of post settlement alluvium caused by increased discharge alone cannot be measured.

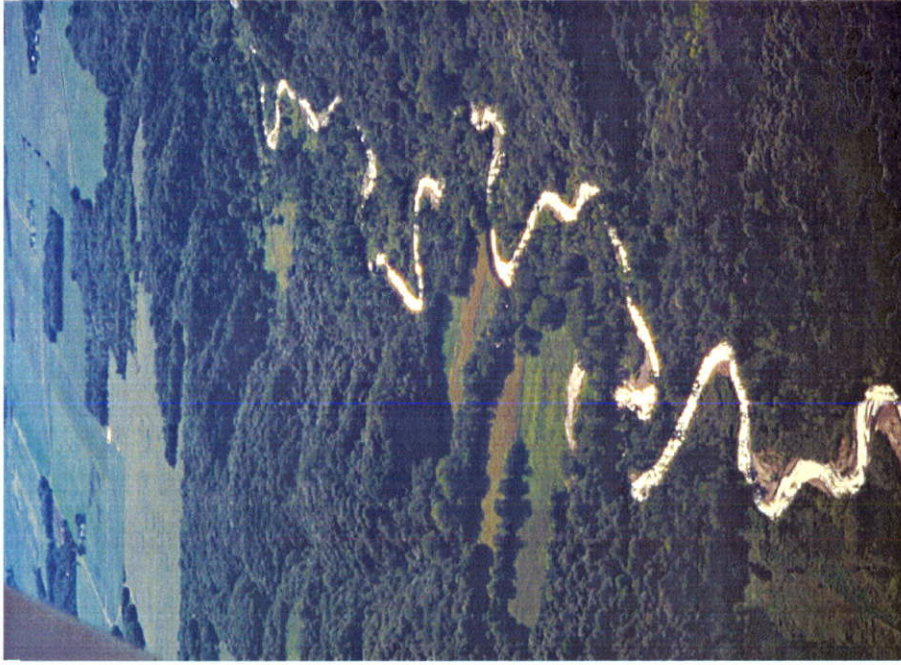
Figure 8. Two segments of the same stream, the Rush River. On the left is an original segment of the stream, and on the right is a ditch.

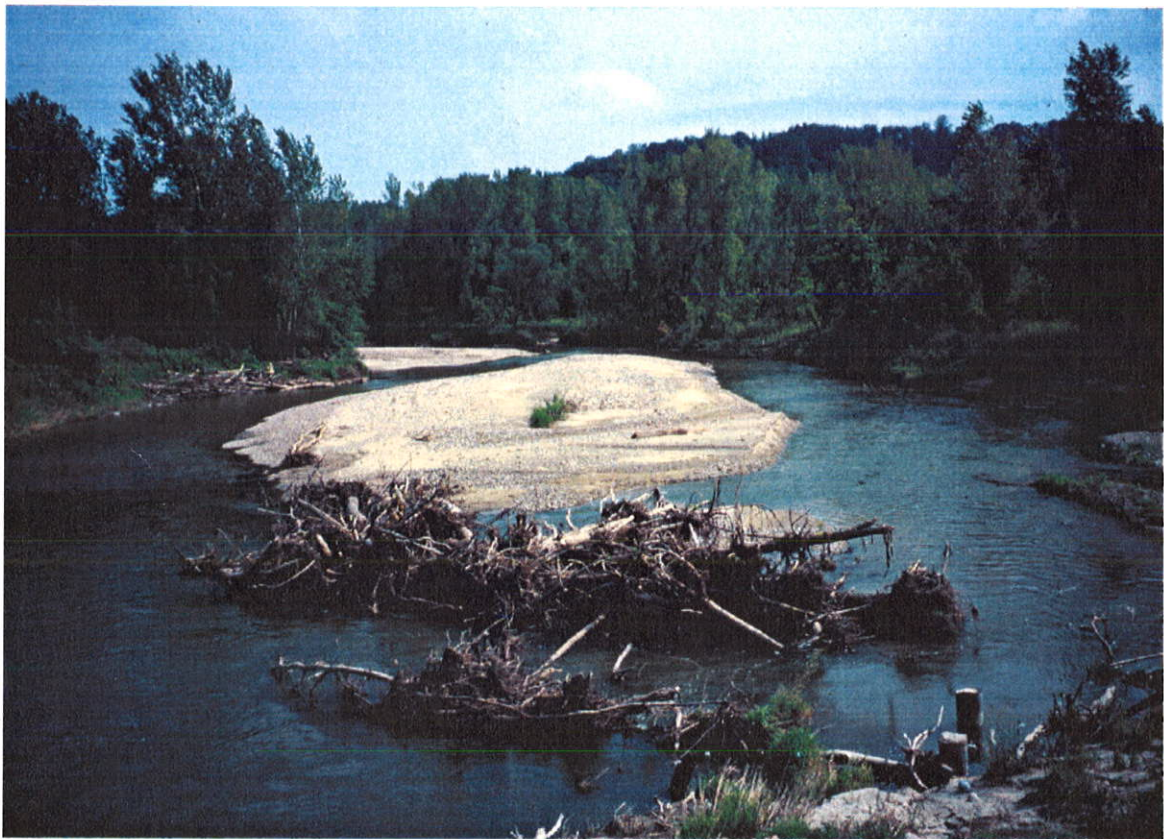
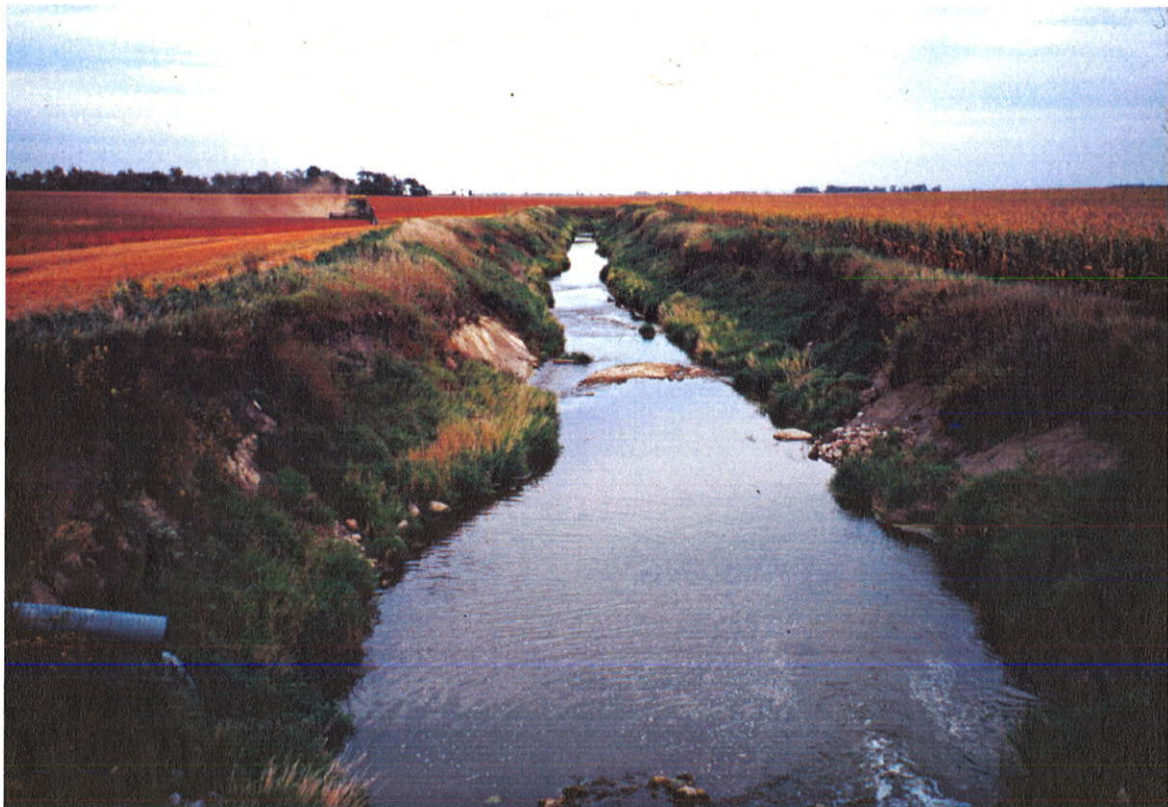
Figure 9. Original (above) and ditched segments (below) of the Rush River. Notice the tile line in the foreground of the bottom photo.
