**RAVINE DEVELOPMENT AND BANK RECESSION OF RAVINE Z  
IN SEVEN MILE CREEK PARK**

A thesis submitted in partial fulfillment of the requirements for the degree of Bachelor of  
Arts  
(Geology)  
at  
GUSTAVUS ADOLPHUS COLLEGE  
2009

## **ABSTRACT**

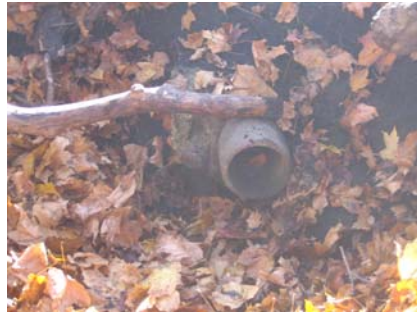
**Figure 2.** The cement pipe above is the outlet at the head of Ravine Z, and about 8 inches of cement is visible to the left of the pipe which is only visible after headward erosion.

currently at approximately 310 meters above Seven Mile Creek. At the head, a concrete pipe with a 5 inch diameter protrudes 9 inches from the eroding earth. The walls for the next 200 meters, which is referred to as the Upper Ravine Profile in Figure 9, are generally U-shaped. The vegetation is abundant, with trees of diameter between 3-12 inches, and the walls are parallel enough to the ground that trees are still stable on the slope.

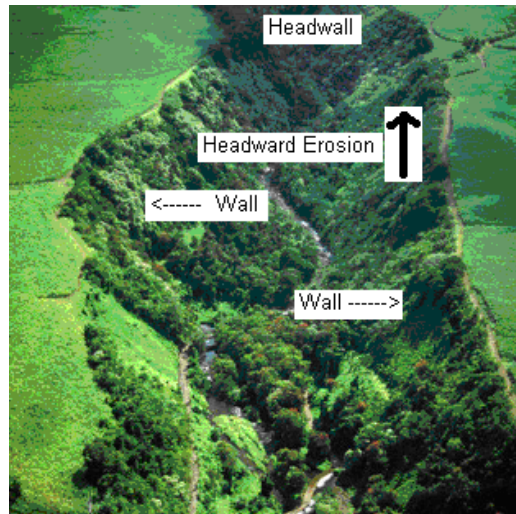
**Figure 3.** This is an aerial photograph of a typical ravine. The walls are located along the sides, and headward erosion is upstream, toward the head. The head is located at the source of water, and is always at the highest elevation. Photo taken from <http://pro.corbis.com>.

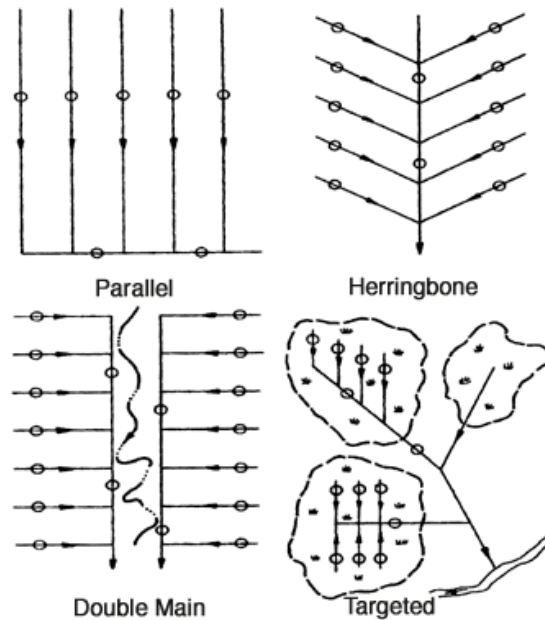
**Figure 5.** The four patterns above are all ways of implanting drain tile on agriculture. Parallel is the most common, and is the tile used in most Southern Minnesota farms. The arrows shows the direction of flow, and all systems but the Double Main have only one outlet pipe.

An increase in groundwater is likely the reason for increased activity in most ravines, and artificial drainage like drain tile may potentially be the main contributor. Drainage tiles are used to lower the water table, and drain soils which are seasonally wet, as most are in the Midwest. Drain tile allows farmers to begin the planting season earlier, along with keeping the overall conditions of the soil more stable than farms with natural drainage. The different patterns of drain tile shown in Figure 5 are used depending on the topography, and parallel is the type used in southern Minnesota. There are many variables associated with variations in soil behavior but the two most relevant are soil type, and rainfall infiltration (Schilling and Helmers, 2008).

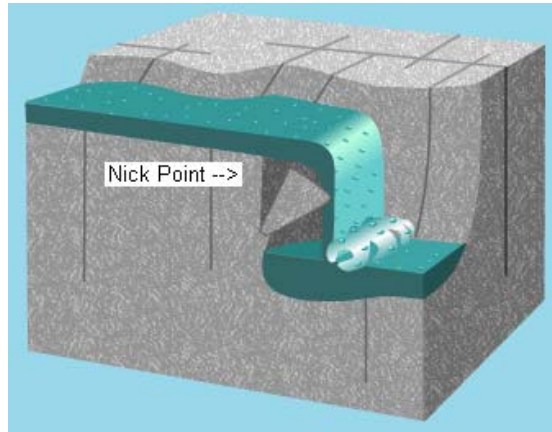
**Figure 6.** The water falls over the nick point, and erodes the underlying land. It moves in the headward direction. Image taken from <http://www.classzone.com>.

Seven Mile Creek is in a geologically young area. This study is designed to show changes in sediment storage at significant spots, and also to show how quickly the gully head and walls of one gully are receding. Determining nick points is crucial for finding where the majority of the down cutting occurs, and finding patterns for how the landscape is eroding. The water falls over the nick point, like in Figure 6, and erodes away the bottom, until finally the wall falls. This is the process of nick point migration against the direction of water flow.

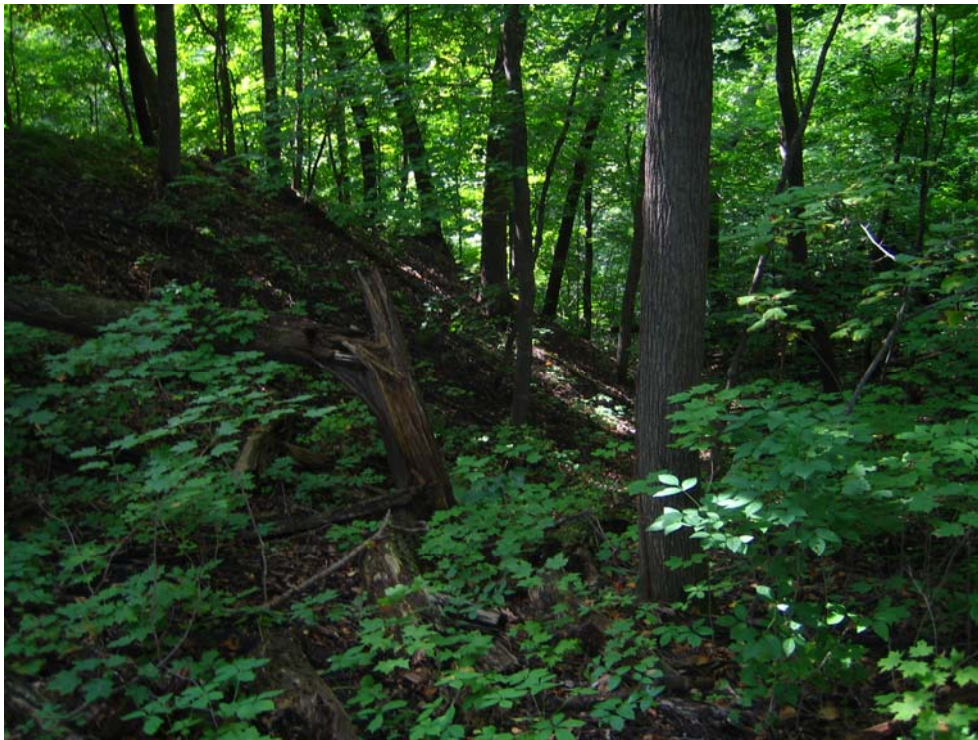
**Figure 9.** A typical portion of the Upper ravine. Note gradual slope, and abundant vegetation. The next two hundred meters are steep walls ranging from 10-35 feet, with small plants, many fallen trees, and trees of 2-6 inches in diameter just above the walls. This begins at the Mid Ravine Profile, and ends just after the highest nick point at 345 meters from the bottom. At this point, the topography above the walls gets steeper, and there are

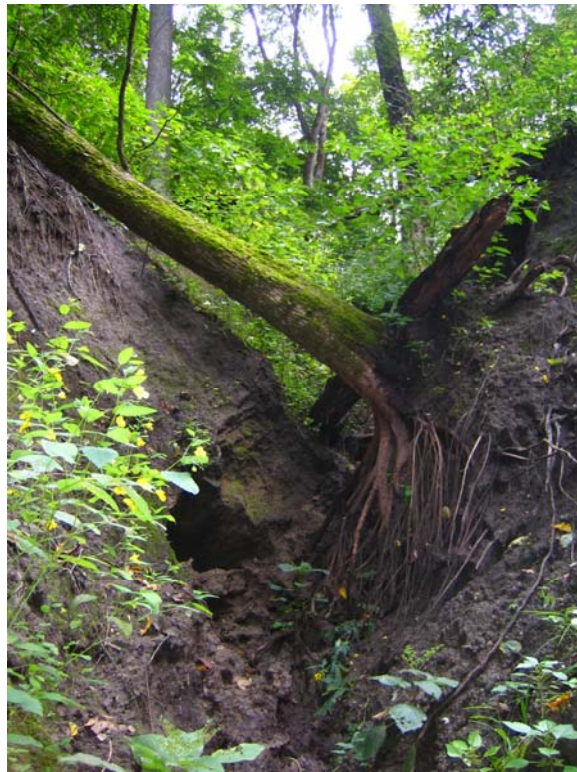
**Figure 10.** Picture taken just below 345 meter nick point. Walls become steeper at this section, and roots become exposed as root systems fail.

large fallen trees on the hill slopes, with about two inches of fallen leaves. One highlight of this stretch is that there is one nick point, but it is not as easy to distinguish from the landscape as the lower nick point. The vegetation at the bottom of the nick point helps it blend in, and disguises the abrupt change in slope.

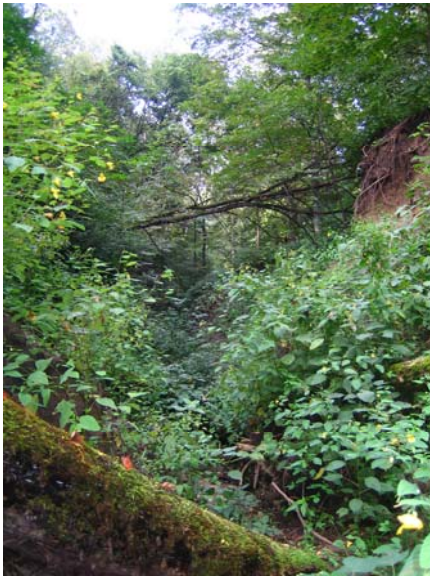
**Figure 11.** Just below the 183 meter nick point. Large fallen trees, steep walls, and vegetation.

The last 230 meters are very active, and at the main nick point, there are large roots sticking out and holding in the sediment. There is a large tree with a diameter of about 30 inches at the top of the nick point that likely is restricting the nick point from eroding as fast as it would without the tree at that location. There is massive vegetation all around this point, and down to the bottom. The walls have more of a layered

appearance with fill on the walls just below the nick point from the damming event mentioned later. The bottom has large amounts of sand that becomes finer grained as it stretches to the lowest elevations. There are also rocks on the bottom in the size range of 1-3 inches in diameter. The walls just below the nick point are about 18 feet tall, and very steep, and the walls lower by about 5 feet every 75 meters. The body of the ravine ends about 10 meters short of the path, and the land between is filled with sediment that water of heavy flow has carried out of the ravine.

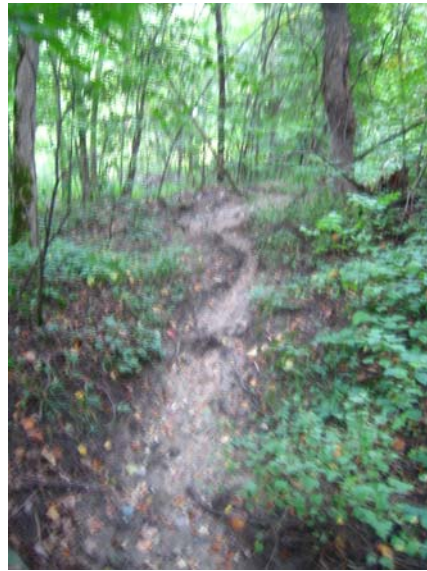
**Figure 12.** Note the sandy bottom. This is Forty feet from the end of the ravine.

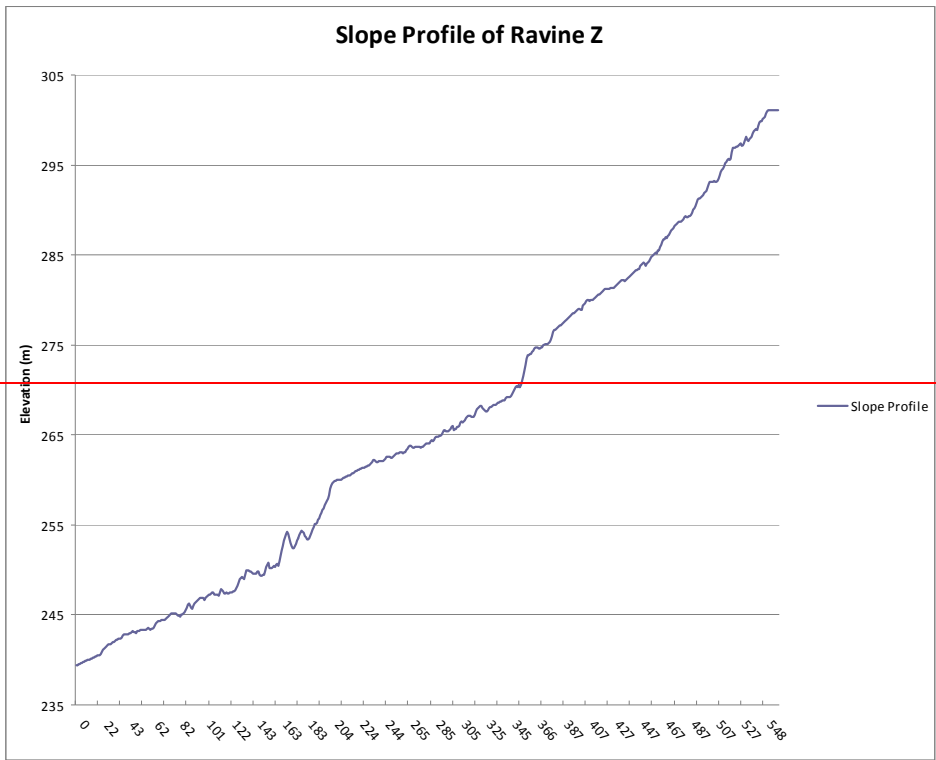
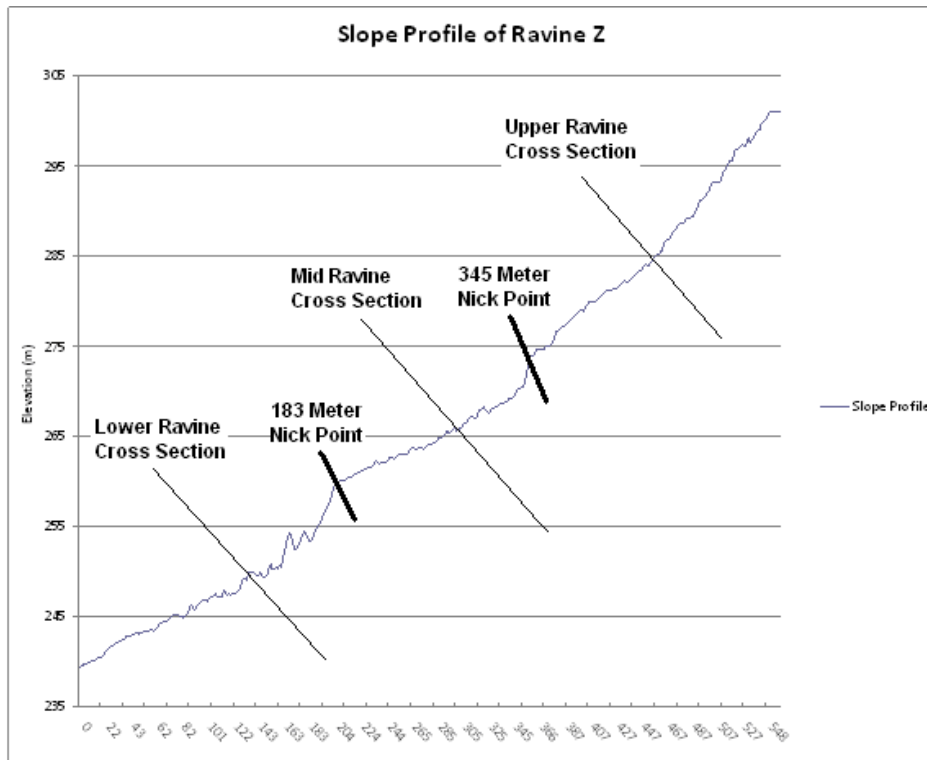
**Figure 13.** Slope profile of Ravine Z, highlighting the two nick points, and the location of each cross section.

Using ArcGIS, a slope profile was constructed from the bottom of Ravine Z, following the lowest point of the ravine all the way to the top at the flat land just above the drainage pipe. The average slope of the profile is .11. The location of nick points is shown in Figure 13 above.

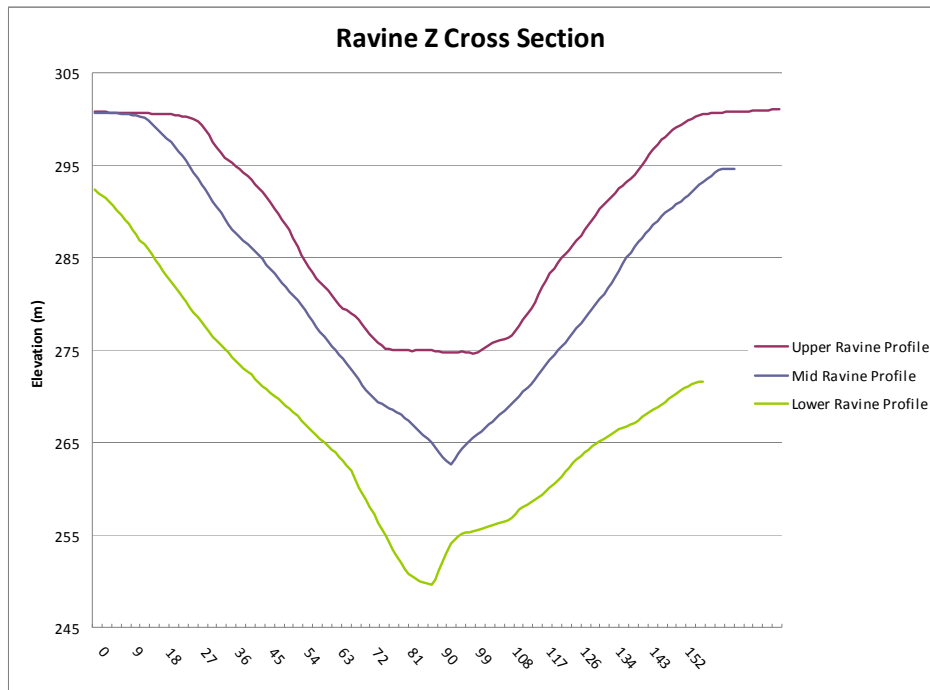
**Figure 14.** Cross section of Ravine Z. Note the differences in the shape of the bottom of the three profiles.

Again with ArcGIS, a cross-sectional slope profile was constructed to create the Upper, Mid, and Lower ravine profiles. Each cross section is 200 meters apart, dividing the ravine into 3 equal parts. Placing all three cross-sections in the same figure not only shows the difference in elevation as one travels toward the head, but also the change in shape of the walls and bottom. In the lower profile, the ravine makes a fairly rounded V shape, and the left side is much taller and steeper. The middle third is a sharp V, and the shape of the bottom is the same as travels up the walls. This part of Ravine Z is very steep, with tall walls. The upper portion of the ravine is more of a broad shape like a U, with walls that are not as high as walls in the lower parts of the ravine.

Fill around the nick point was probably the result of some kind of constriction in flow occurring somewhere just below the nick point. In Figure 9, note that the bottom of the upper ravine cross-section is rounded, and appears to be filled with sediment, while the other two have eroded more into a V-shape. Similarly, below the nick point at 183 meters, sediment built up, leaving a layering of fill along the walls. The two nick points
